Technical News

Ref. No.	Issuer company	Issue (yyyy/mm/dd)	Last modification (yyyy/mm/dd)
PV18NEX531	Digital Imaging Group	2018/09/14	
Subject			
Prevent lens front breakage			
Model (System model)	Destination	Serial number	Color
SEL2470GM	All	1800001 ~ 1883269

The front of the lens breaks due to drop

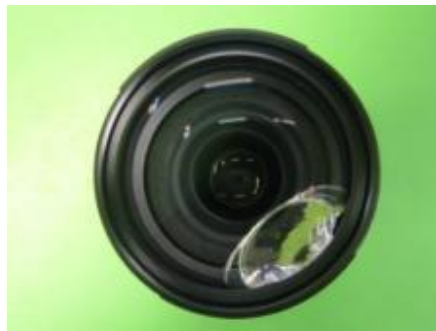
The structure was designed to transmit shocks easily

• Replace the 1ST LENS ASSY (A-2072-006-A).

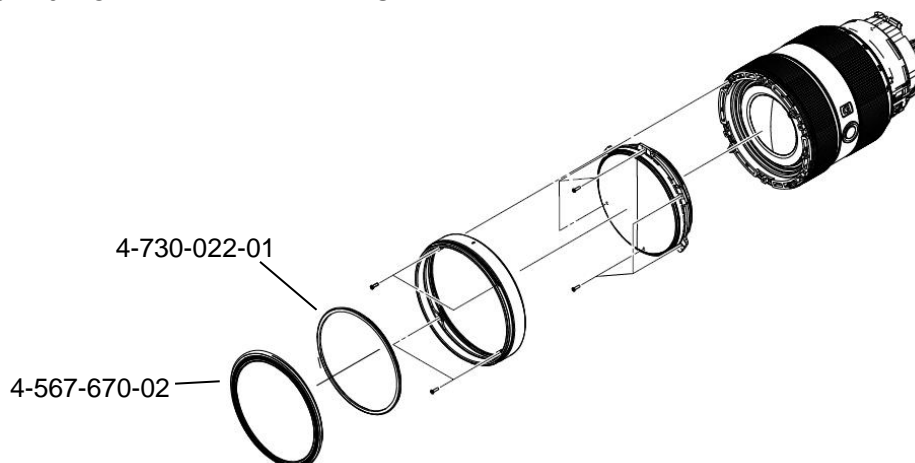
The following parts are changed and added.
 4-567-670-01 ⇒ 4-567-670-02: ORNAMENTAL PLATE
 4-730-022-01: ORNAMENTAL PLATE SHEET

*In case of the assembled ORNAMENTAL PLATE was 4-567-670-01:

1. Add ORNAMENTAL PLATE SHEET (4-730-022-01).
2. Exchange the ORNAMENTAL PLATE to 4-567-670-02
